**DEPARTMENT OF TRANSPORTATION**

Contract #: 04-0120F4Cty: SF/ALA Rte: 80 PM: 13.2/13.9File #: 1x.28**WELDING INSPECTION REPORT****Resident Engineer:** Pursell, Gary**Address:** 333 Burma Road**City:** Oakland, CA 94607**Report No:** WIR-014686**Date Inspected:** 07-Jun-2010**Project Name:** SAS Superstructure**OSM Arrival Time:** 700**Prime Contractor:** American Bridge/Fluor Enterprises, a JV**OSM Departure Time:** 1100**Contractor:** American Bridge/Fluor Enterprises, a JV**Location:** Job Site**CWI Name:** Steve McConnell**CWI Present:** Yes No**Inspected CWI report:** Yes No N/A**Rod Oven in Use:** Yes No N/A**Electrode to specification:** Yes No N/A**Weld Procedures Followed:** Yes No N/A**Qualified Welders:** Yes No N/A**Verified Joint Fit-up:** Yes No N/A**Approved Drawings:** Yes No N/A**Approved WPS:** Yes No N/A**Delayed / Cancelled:** Yes No N/A**Bridge No:** 34-0006**Component:** OBG Sections**Summary of Items Observed:**

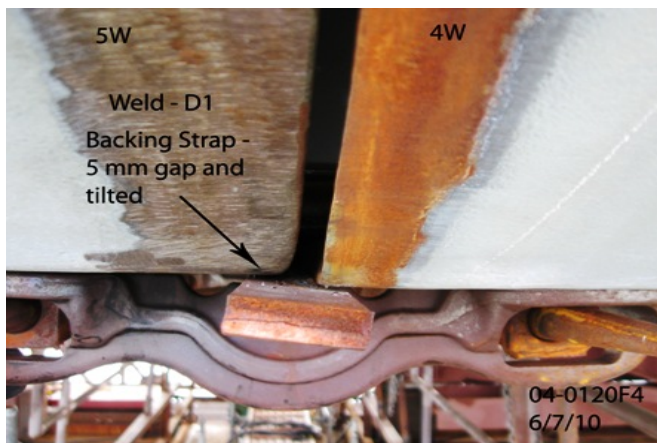
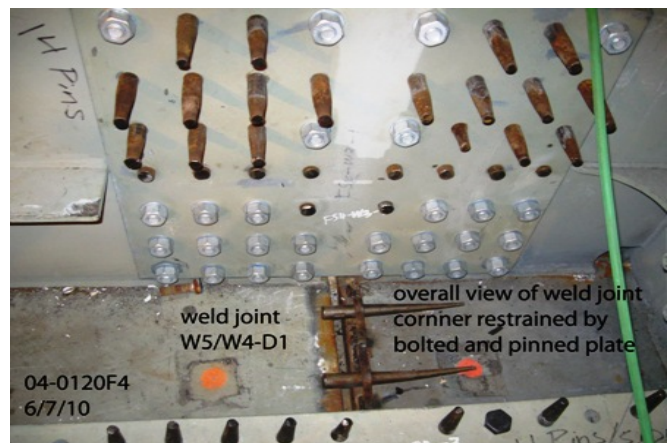
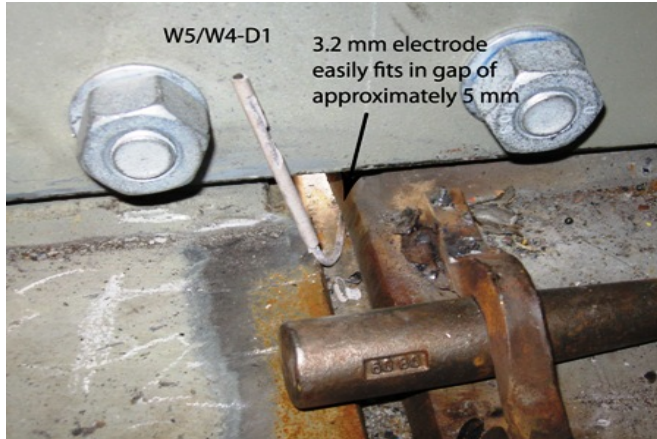
3) At weld joint W4/W5- D1 and W4/W5-C2 this QA Inspector observed work in process for the fit up of weld joints currently consisting of a 5 mm gap between the backing strap at D1 and 7mm plainer offset at C2.

At weld joint W1/W2- C2 this QA Inspector observed QC Inspector Bonifacio Daquinag Jr. and Tony Sherwood measuring and verifying the locations of weld defects using the Ultrasonic Inspection Test report generated for this weld. The QC Inspectors were working with ABF welding personnel James Zhen (#6001) and Chun Fai Tsui (#3426) to determine which side of weld would be excavated to facilitate repair welding (inside or outside). This QA Inspector observed ABF welding personnel Chun Fai Tsui (#3426) excavate a repair area from the outside surface adjacent to bottom plate "D" which was approximately 110 mm in length, 20 mm wide and 14 mm deep. No welding was observed during this QA Inspector's shift.

This QA Inspector observed the work in process for the fit up of weld joint W4/W5- D1. This QA Inspector observed that work had not been started on adjacent weld joint W4/W5-C2. From outside the Orthotropic Box Birder (OBG) this QA Inspector observed the backing strap at the beginning of D1 appeared to be tilted, see photo below. This QA Inspector went inside the OBG, measured the plainer offset and examined the fit up of the backing strap from the inside. The plainer offset between the two OBG sections appeared to be approximately 2mm, this QA Inspector observed there was a gap between the bottom of the plate (OBG section W5) and the backing strap which was approximately 5mm. See photo below of 3.2 mm diameter electrode between the plate and the backing strap. The plainer offset between W4 and W5 on the outside of the OBG adjacent to D1 at the end of C2 was measured to be approximately 7 mm. Please note the splice plate directly above this section of weld is bolted and pinned, see overall inside photo below. QC Inspector Jesse Cayabyab was present and informed this QA Inspector he was aware of the offsets and gap.
